Special Report 77-43

CRREL ROOF MOISTURE SURVEY
Building 208
Rock Island Arsenal

December 1977

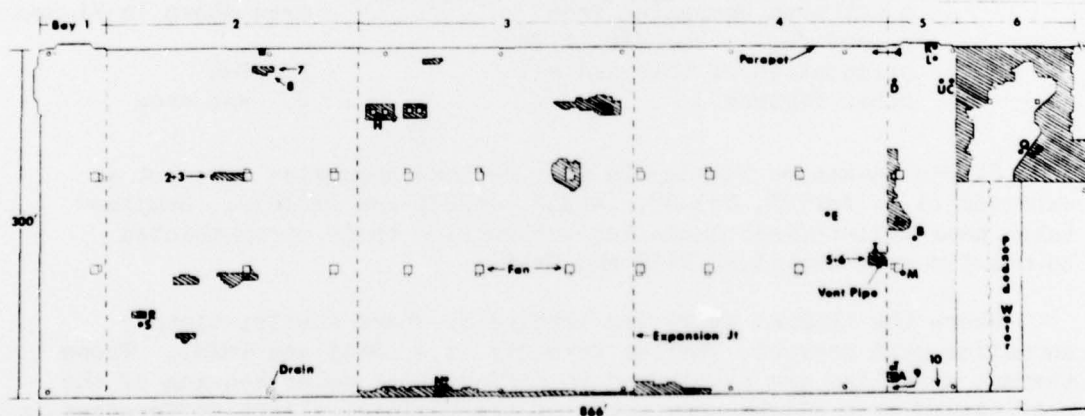
Figure 1. Plan view of building 208. The cross-hatched areas indicate wet insulation. Arrows indicate the viewing direction of objects in Figures 2 through 10.

SAMPLE-% WATER		SAMPLE-% WATER	
A	170	L	2
B	3	M	3
C	4	N	3
D	5	O	318
E	2	P	216
G	398	Q	5
H	235	R	155
I	435	S	3
J	223	T	4
K	1	U	2

Much of the northern portion of Bay 6 contains wet insulation. New built-up roofing and insulation are needed there. Careful attention should be directed toward installation of new wall flashings as it is quite likely that flashing flaws destroyed this portion of the roof.

New insulation and a built-up membrane are needed for the northern portion of Bay 6. Better drainage should be provided in the southern portion of this bay.

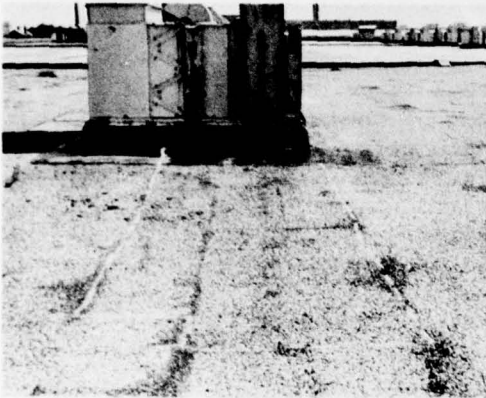
Figure 2. White spray paint outlines a wet area emanating from a roof fan. (See Fig. 1 for orientation of this and all other figures.)

Samples taken on Tuesday in well-defined anomalies were wet as expected (i.e. A=170%, G=398%, I=435%, J=223% and O=318%). Samples taken near well-defined anomalies but outside their spray-painted boundaries were dry (i.e. N=3% and T=4%).

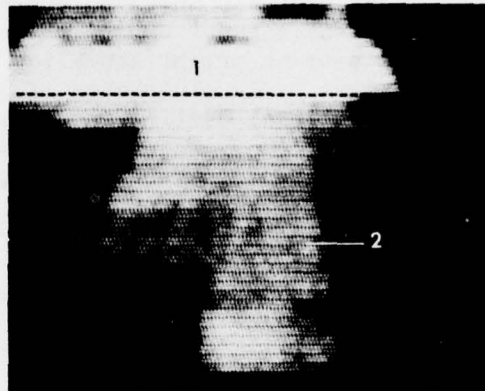
Figure 3. Thermogram of the wet area shown in Figure 2.

1. Fan
2. Wet area

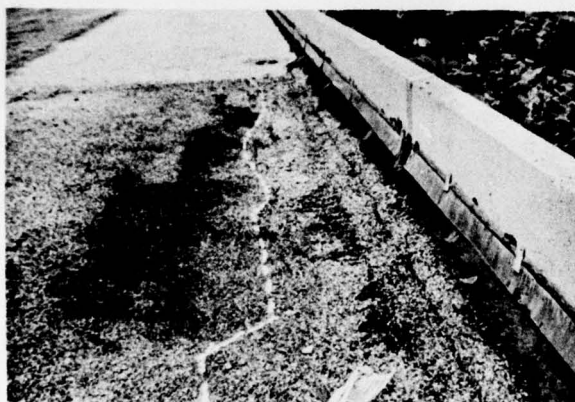
unrelated to moisture are frequently encountered there. The anomalies detected in these areas appeared to be of this nature, except that their inside boundary was quite irregular (Fig. 4), which is uncommon. Since anomalies with irregular boundaries are often moisture-related, samples were taken. All insulation samples associated with these types of anomalies were dry (i.e. C=4%, D=5%, K=1%, L=2% and U=2%). The membrane was thicker within these anomalies. This is believed to be the cause of their thermal signature.

Figure 4. Spray painted boundary of an irregular thermal anomaly along the parapet.

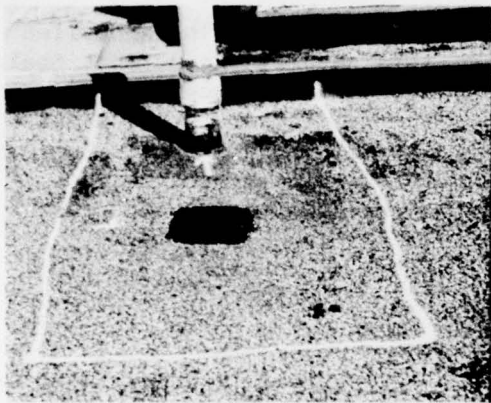
The majority of the wet areas shown in Figure 1 are associated with membrane penetrations. Quite likely water has entered the insulation through the flashings at these penetrations. For example, the flashing collar was loose at the base of a vent pipe. The collar would move relative to the pipe when someone walked nearby. Figures 5 and 6 show the well-defined wet area surrounding this vent pipe. The collar was not loose at an identical vent pipe nearby and the thermal image was

Figure 5. Daytime photograph of a wet area outlined with white spray paint. The arrow points to the loose collar flashing. The built-up membrane contained a 3-in.-diam hole which was subsequently patched (black square).

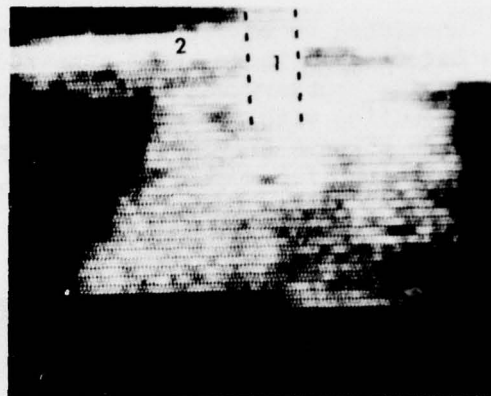
Figure 6. Thermogram of the area shown in Fig. 5. The moisture probably entered around the vent pipe.

- 1. Vent pipe
- 2. Expansion joint

uniformly dark there. Within the wet area shown in Figure 6 a 3-in.-diam hole was discovered in the membrane. Sample I, taken from the exposed insulation, had a water content of 435%. Prior to completion of this survey the hole was patched as shown in Figure 5.

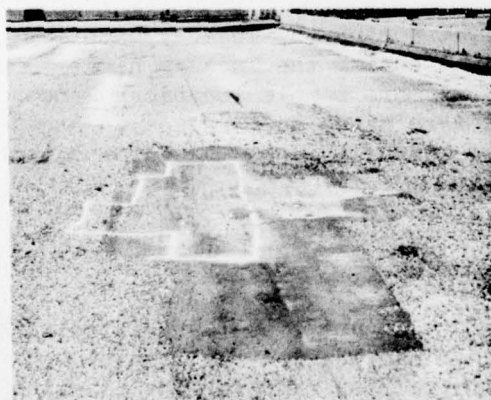
Other wet areas were associated with roof patches as shown in Figures 7 and 8. It's not possible to determine when moisture entered this area - before or after the patches were installed.

Figure 7. Daytime photograph of a patched area with a wet area outlined in white spray paint.

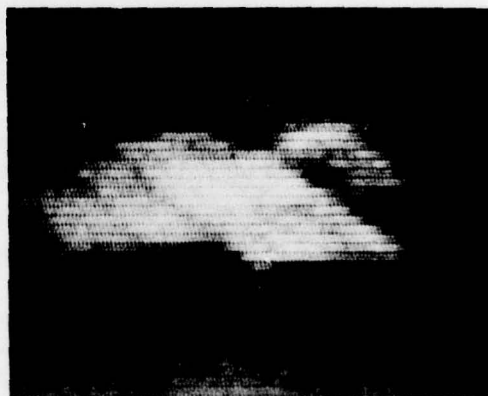
Figure 8. Thermogram of the wet area shown in Fig. 7.

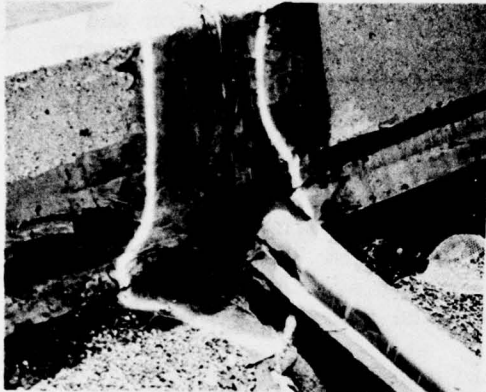
Visual examinations conducted during the daytime (26 and 27 July) revealed that the entire roof membrane contained numerous blisters. Although blisters are potential moisture entry points no wet areas were directly associated with blisters. While the flashings and expansion joints were being examined, defects were marked with white spray paint, as shown in Figures 9 and 10. Repairs should be made in such areas.

Figure 9. White spray paint was used to mark defects.

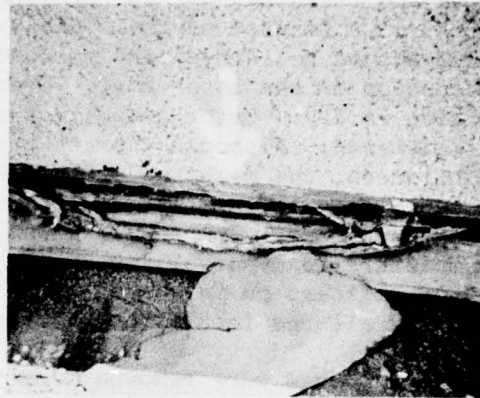
Figure 10. Flashing defect marked with white spray paint.
